Chad Soard  
Trifecta Wildlife Services, LLC

# 1 BATS IN THE BELFRY WAY

Thursday, July 12, 2018

26 Issues Identified

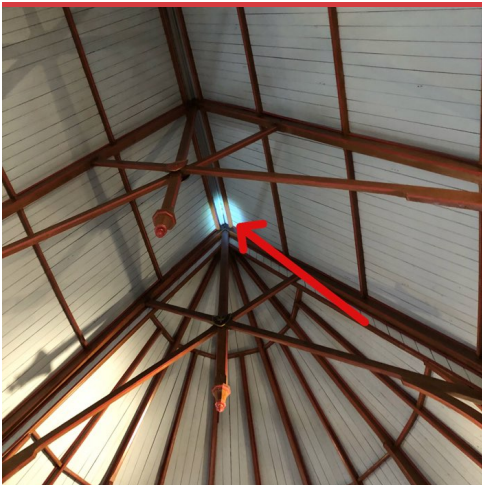
### ISSUE 2

Gapping between wooden supports and wall above wood organ pipes where bats are likely roosting at times; none observed here during inspection.

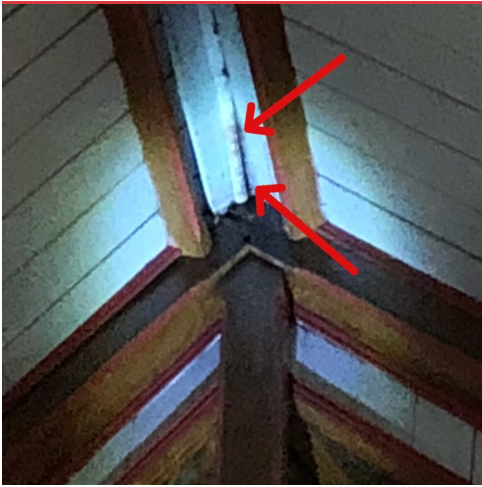
### ISSUE 3

An evident point of entry to the church interior.

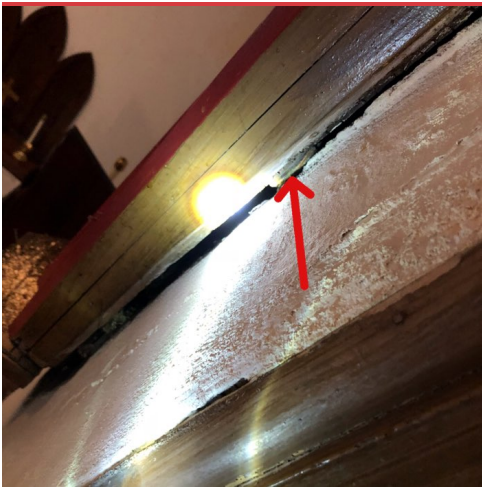
#### ISSUE 4

Close up of Issue 3 showing body oil dirtying and a construction gap allowing the bats passage.

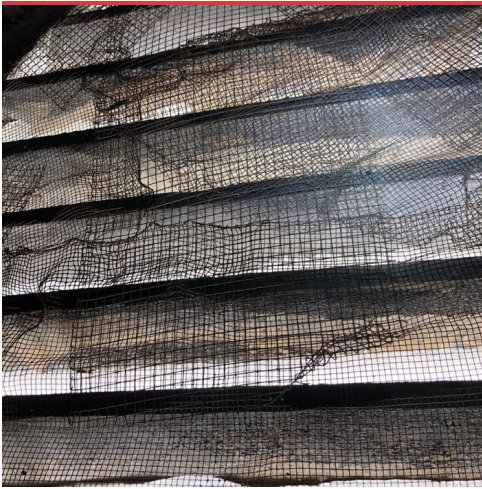
#### ISSUE 6

One of the four gable vent interiors in the bell tower. Interior screening is present, but not all in good repair and we recommend exterior screening for best protection.

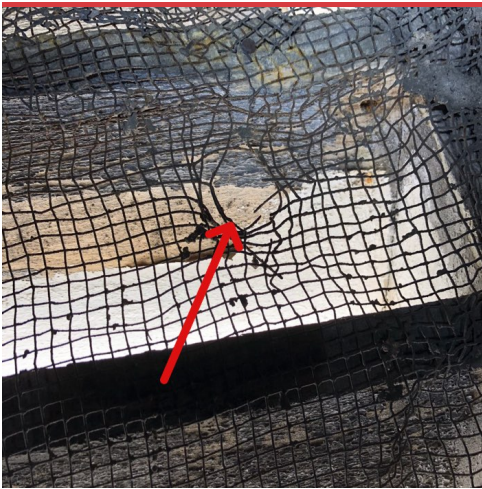
### ISSUE 7

View of one of the four gable vent interior screens showing its cobbled together.

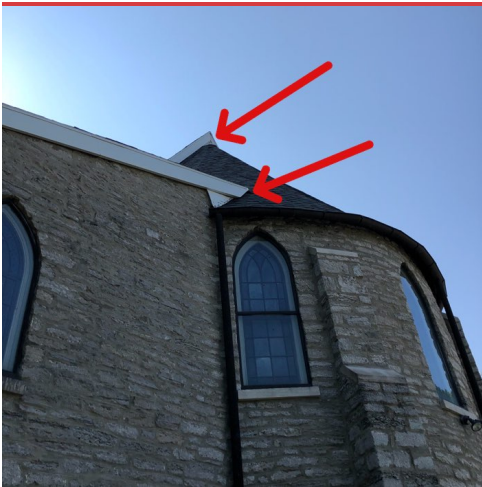
### ISSUE 10

This area where flashing overlaps roof should not be vulnerable to bat entry if properly step flashed beneath but sealing to roof shingles may be prudent.

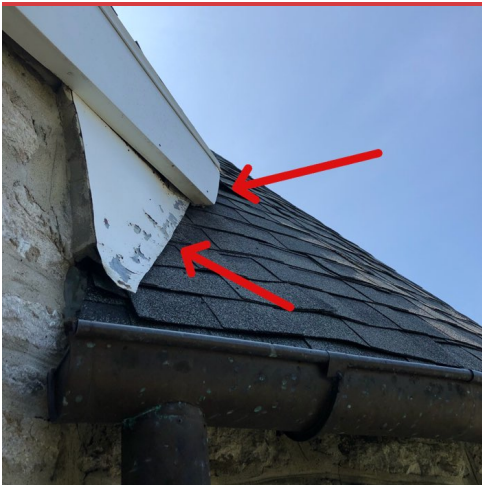
### ISSUE 11

Two primary areas of current bat entry we observed.

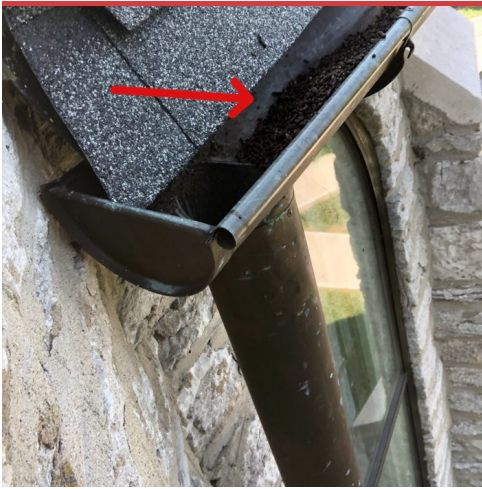
### ISSUE 12

Close up of a primary bat entry where a large construction gap exists at this return/roof junction. Some pieces of guano can be observed on roof.

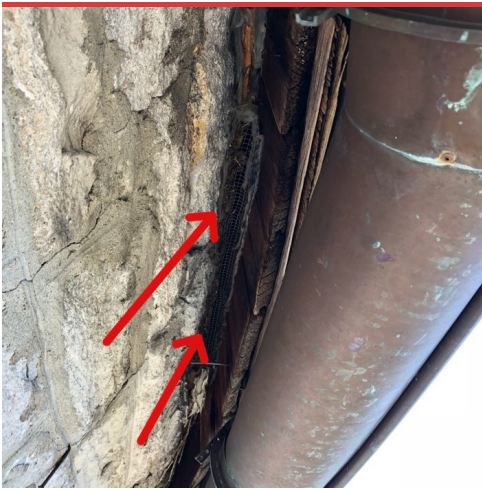
**ISSUE 19**

More of the roof perimeter where sealant needs applied/refreshed.

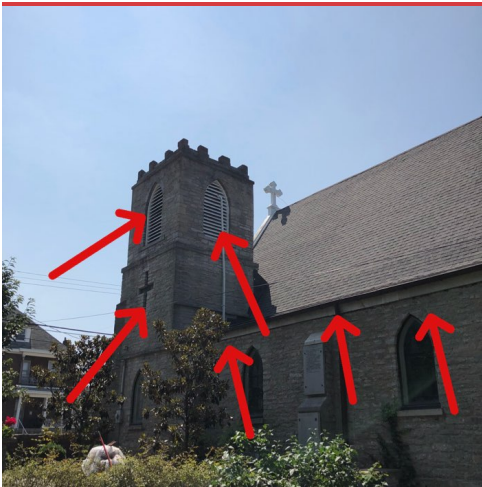
### ISSUE 22

Horizontal issues point to primary bat entries, vertical arrows indicating roof and fascia perimeter areas needing sealant applied/refreshed.

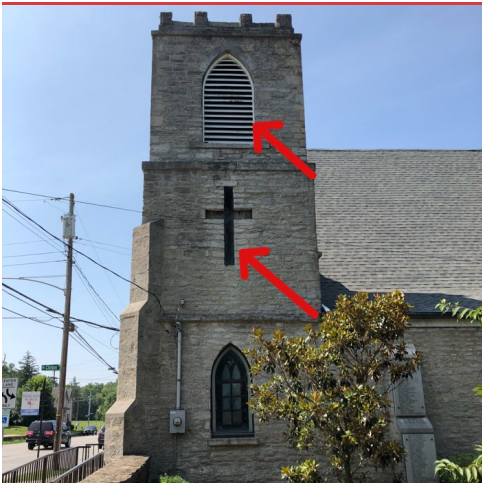
### ISSUE 23

Gable vents to screen on exterior, also exterior screen stone crosses (replace current loosely affixed screen here), and more fascia/masonry perimeter to seal.

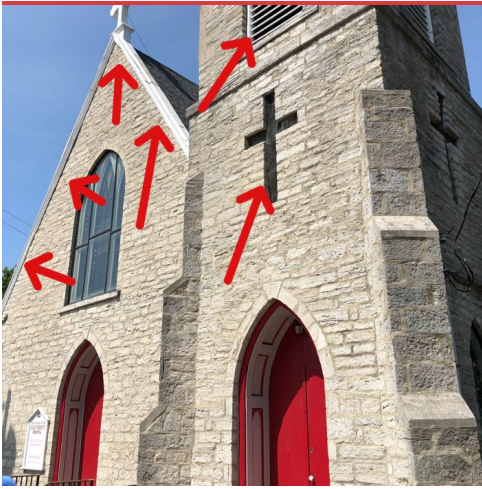
### ISSUE 24

Another view of cross and gable vent to screen.

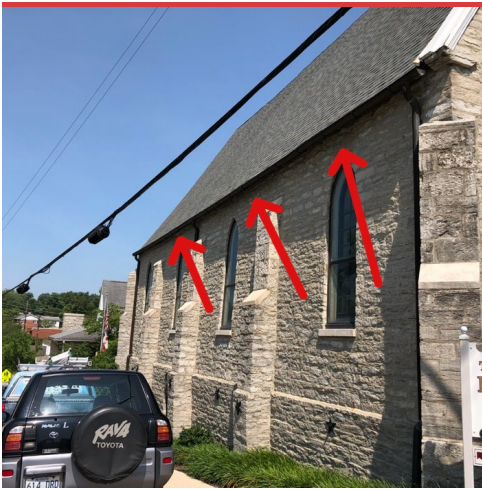
### ISSUE 25

More gable vent and stone cross views, also additional fascia/masonry junction to apply/refresh sealant.
