Chad Soard  
Trifecta Wildlife Services, LLC

# 1 LEXINGTON LN

Tuesday, April 30, 2019

32 Issues Identified

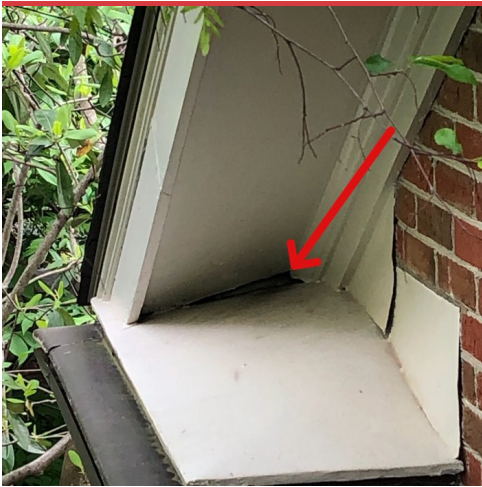
### ISSUE 1

Primary animal entry point at construction gap in this gable end inside corner (flying squirrels strongly suspected)

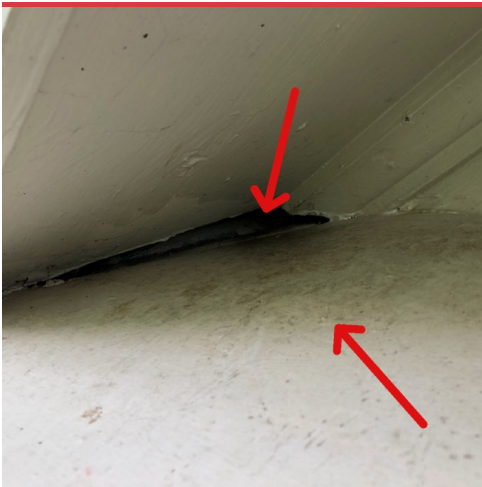
### ISSUE 2

Close up of Issue 1 showing gap and body oils and tracking from animal entry activity.

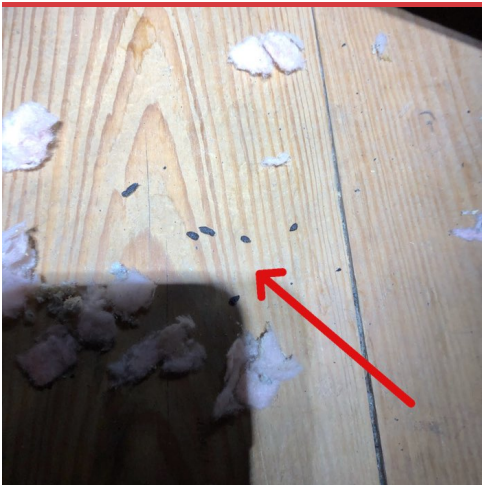
### ISSUE 3

Droppings observed in attic consistent with flying squirrels; mouse droppings were also observed.

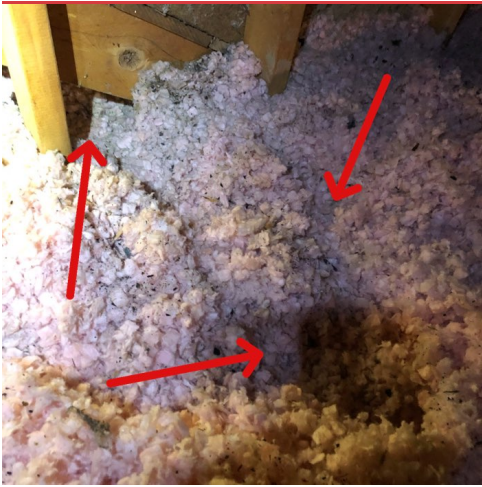
#### ISSUE 4

Trails observed in attic insulation consistent with size of flying squirrels.

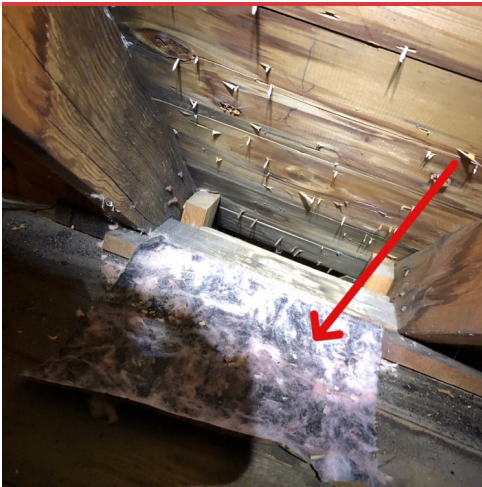
#### ISSUE 5

This piece of insulation observed to be displaced and stripped of the insulating material; possibly taken for nest construction.

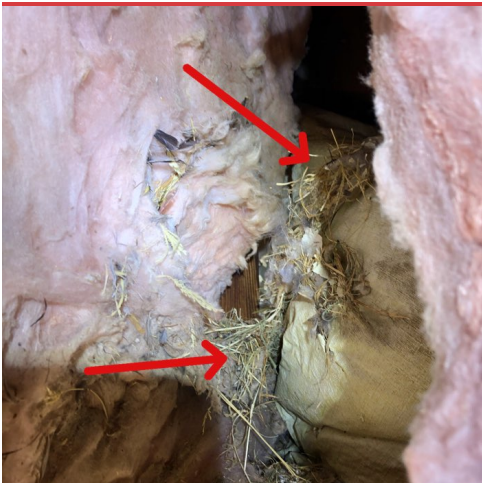
#### ISSUE 6

Bird nesting debris observed in attic at driveway side gable vent where House Sparrows are entering and nesting.

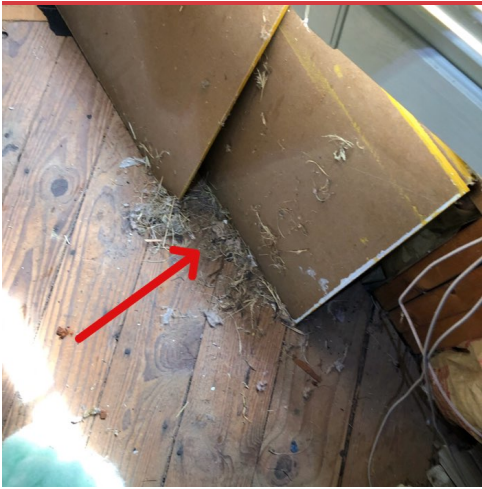
#### ISSUE 7

More bird nesting debris observed in attic under the gable vent.

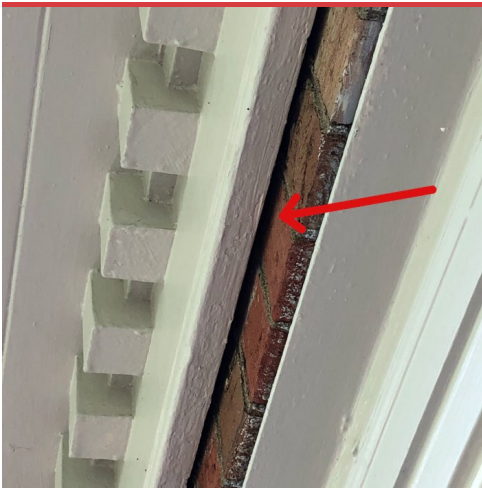
#### ISSUE 8

Fascia/masonry gapping observed in locations around home and is small animal entry vulnerable.

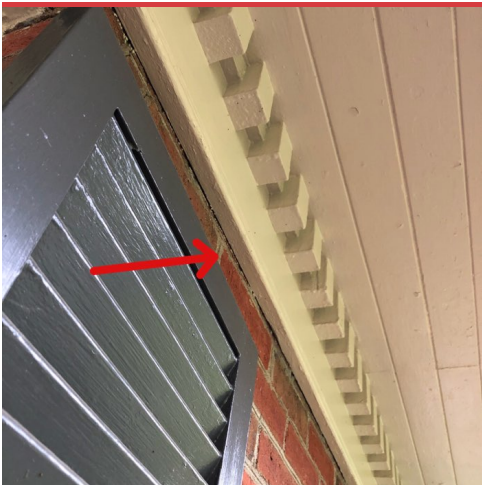
#### ISSUE 9

An example of other fascia/masonry gapping on the home where gapping is not significant; for aesthetics though we recommend sealing all runs.

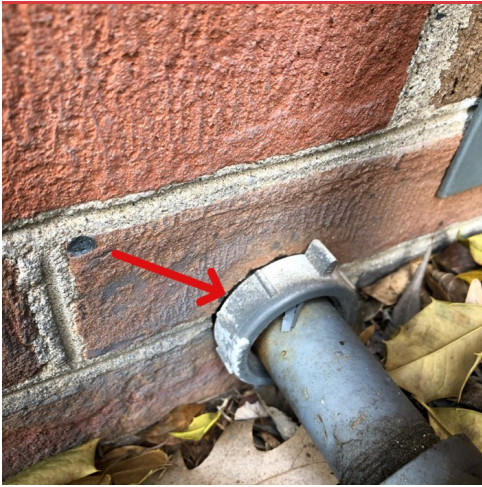
#### ISSUE 10

Small gapping at the gas line chase to seal.

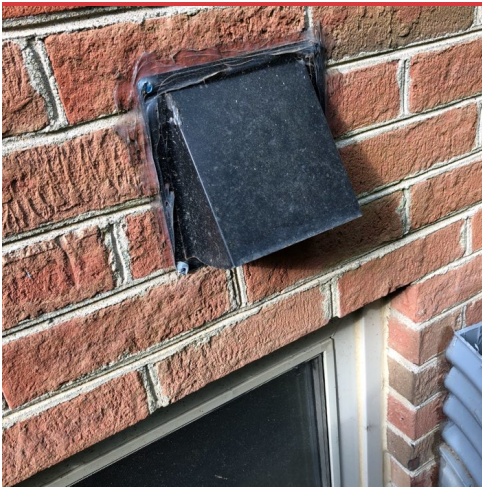
#### ISSUE 11

Of the bathroom exhaust vents, Issue 12 shows it currently has a screen and flapper and is not significantly vulnerable to animal intrusion, but other varieties of pest-resistant vents are available.

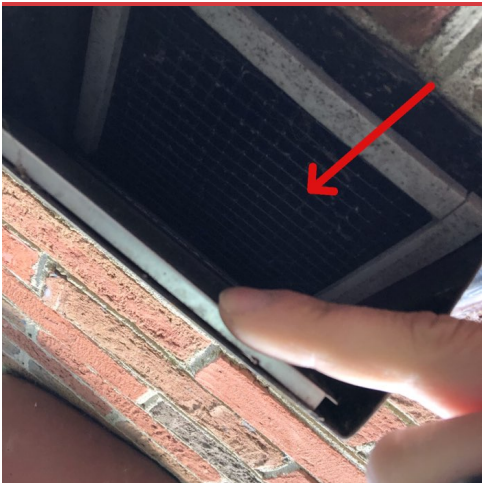
#### ISSUE 12

Vent from Issue 11 showing flapper held up and screen present.

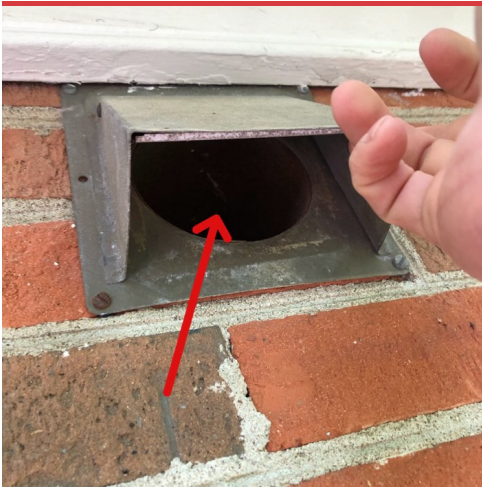
### ISSUE 13

Higher bathroom exhaust with flapper held out has no screen and so is animal entry vulnerable.

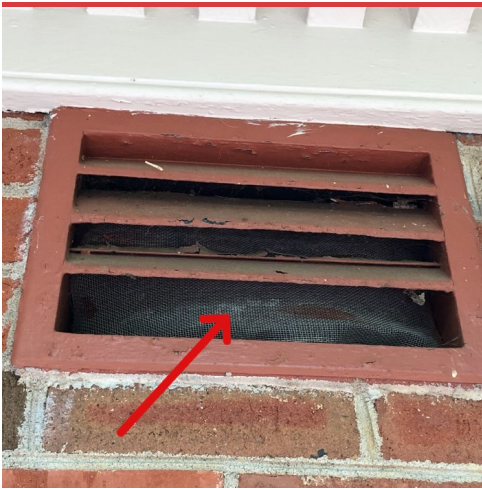
### ISSUE 14

Not sure of this vent's function, but window screening is loosely stuff in and therefore this is left animal entry vulnerable.

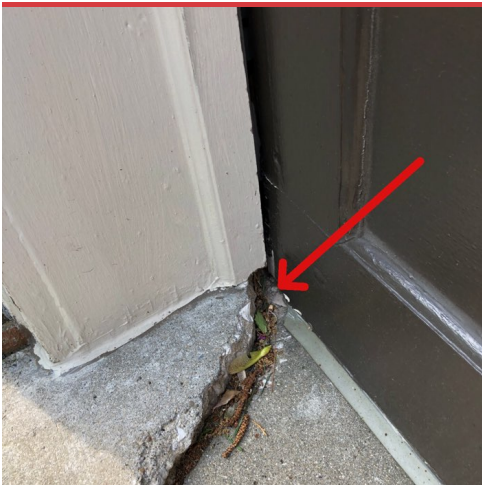
### ISSUE 15

Garage door bottom seal broken at this end; floor crack and settlement makes resolution of this challenging; currently may be considered small animal entry vulnerable.

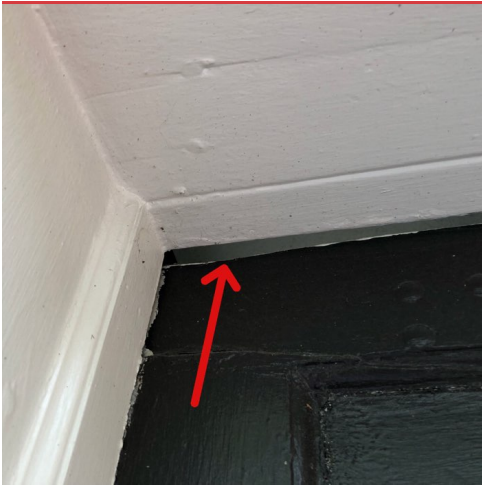
#### **ISSUE 16**

Top of garage door also has a small gap present.

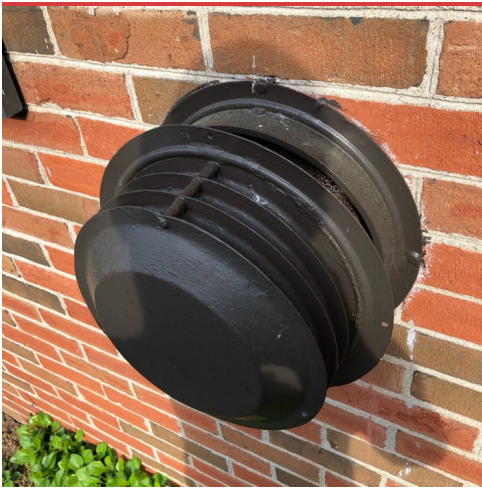
#### **ISSUE 17**

This vent has a broken screen and is being entered by birds as seen in the following two Issues; client has stated it will be removed as it is inactive.

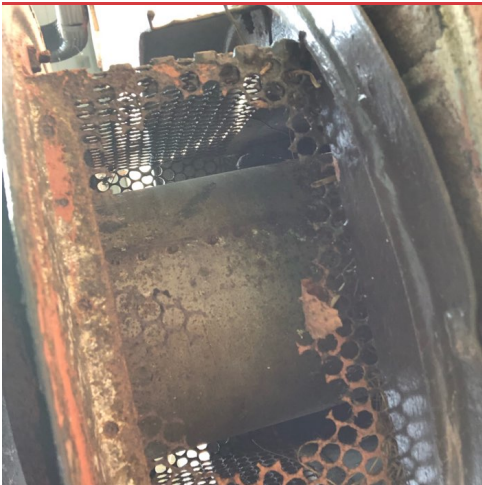
#### **ISSUE 18**

Issue 17 explains

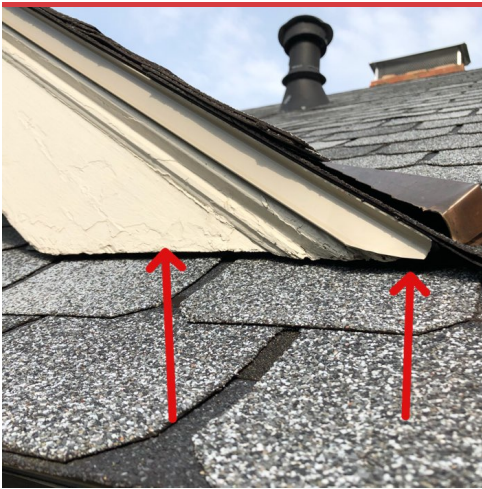
**ISSUE 20**  
Construction gap at this eave end needs sealed.

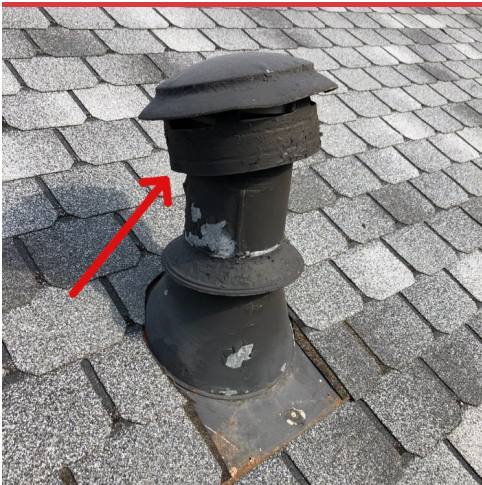
**ISSUE 21**  
Not animal relevant, but observed this to be bent.

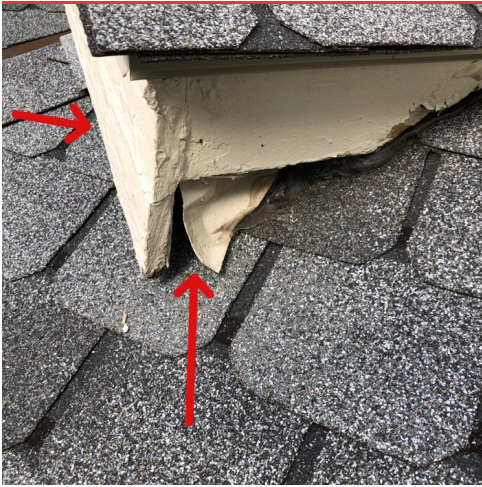
#### ISSUE 22

This eave end needs bent back into place and underside has exposed wood and small gap; recommend cladding with flashing and sealing.

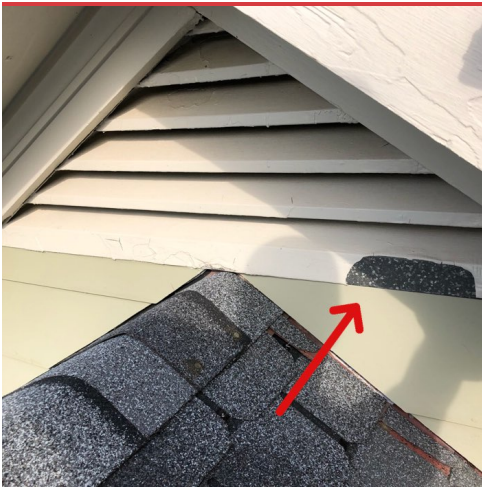
#### ISSUE 23

One of three louvred gable vents, this one with some paint flaking away, but functionally okay; exterior screening recommended to resolve any wildlife issues at all three gable vents.

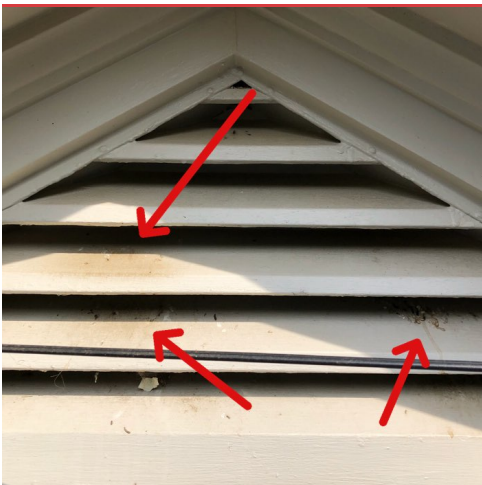
#### ISSUE 24

Gable vent on driveway end of home showing the signs of bird entry.

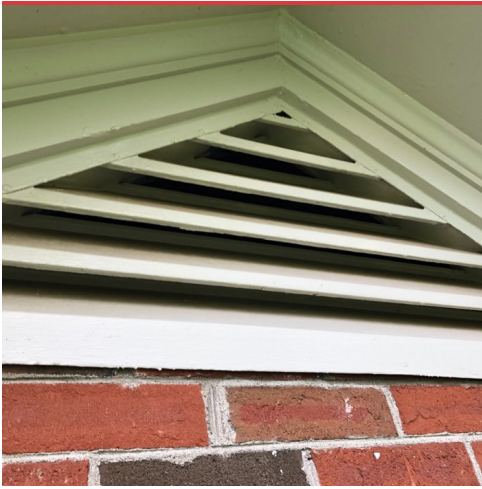
**ISSUE 25**

Third gable vent currently unbreached, but excluding is recommended.

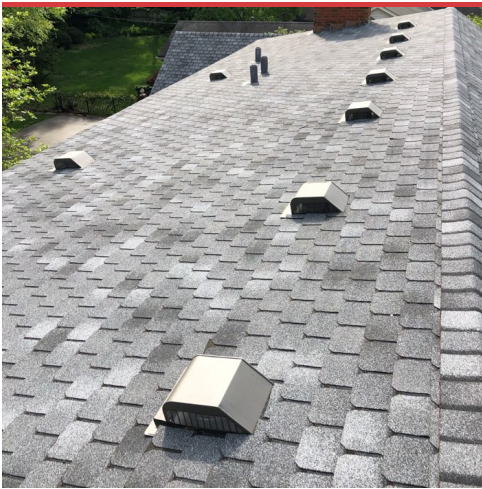
**ISSUE 26**

Nine static box vents that are in good repair, but not protected currently.

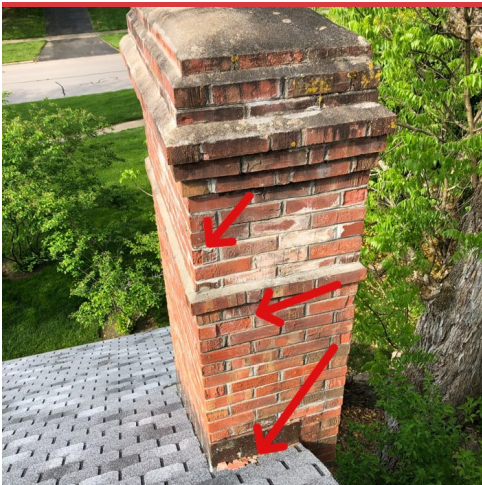
**ISSUE 27**

Brick spalling observed on chimney.

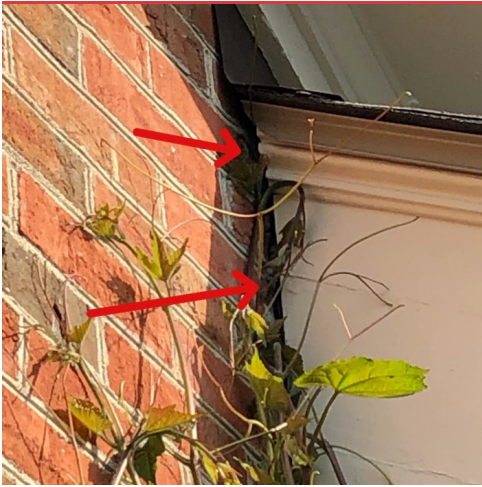
#### ISSUE 28

Construction gap at end of this eave "eyebrow" to seal.

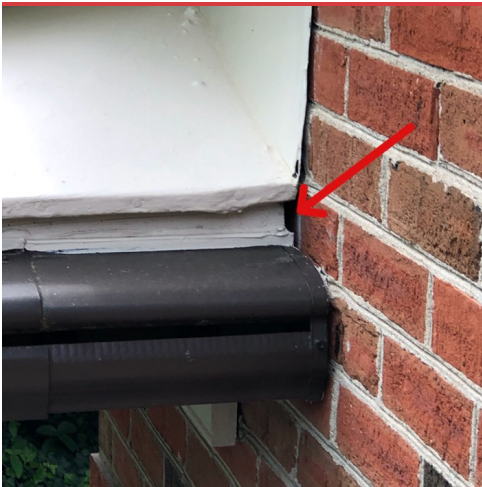
#### ISSUE 29

Small construction gap to seal at this eave "eyebrow."

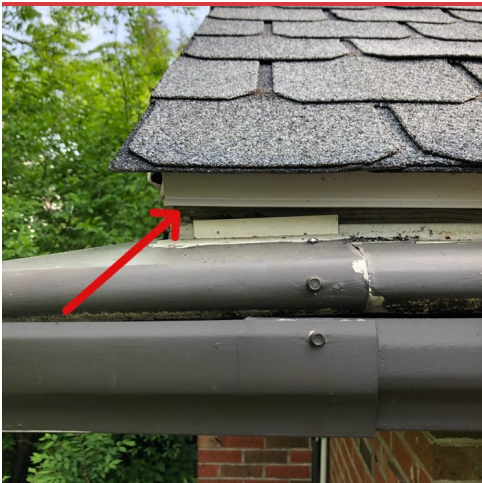
#### ISSUE 30

Small construction gap under this roof corner; Issue 31 shows close up.

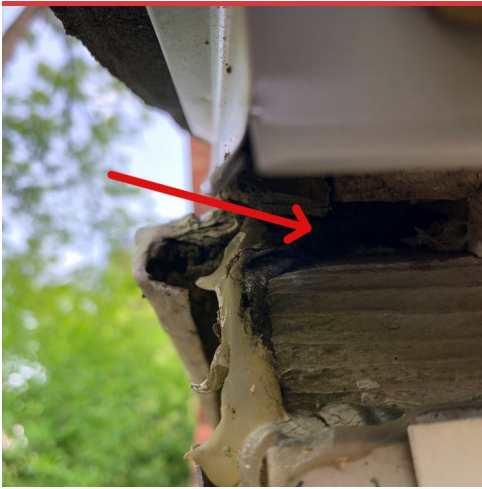
### ISSUE 31

Close up of Issue 30 showing small gap to seal at this roof corner.

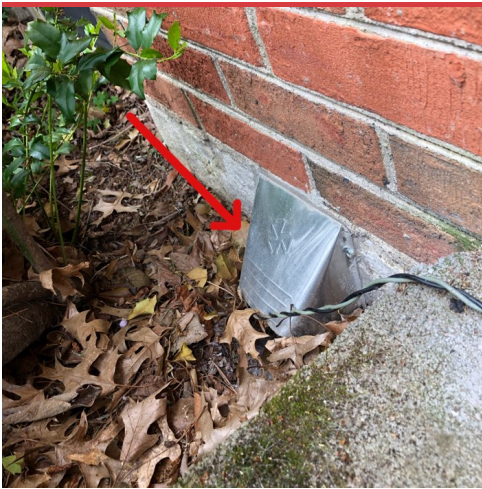
### ISSUE 32

Dryer vent is not a pest-resistant style and may be replaced with one.
